**WALT DISNEY CONCERT HALL – GLARE ISSUE**

# Disney Hall Glare Study

**Schiler and Associates**

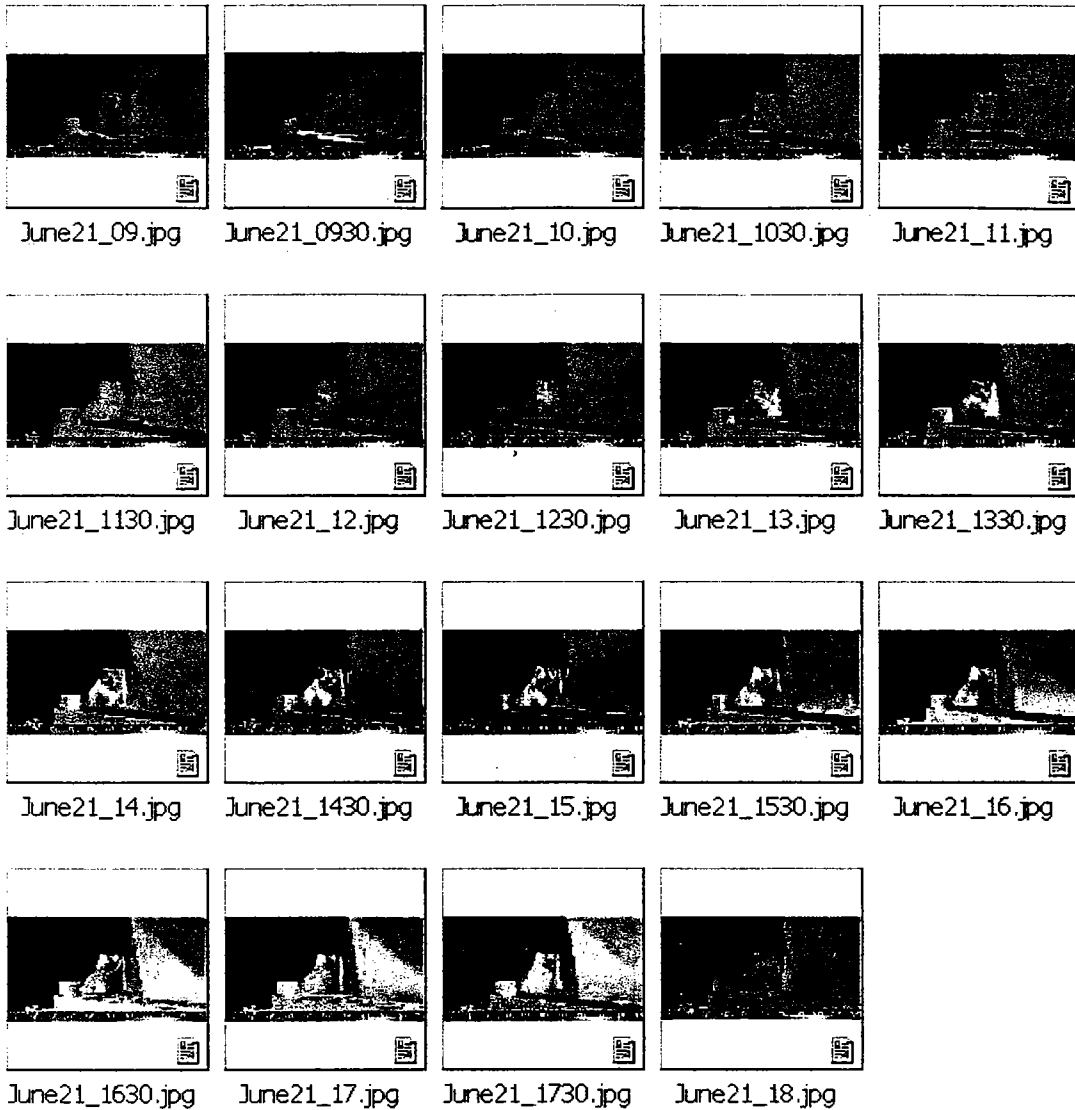
*Luminance Plots of Founder's Room at Half-Hour Intervals for June*

Note the significant areas from 12:30 p.m. to a peak glare condition around 4:00 p.m.

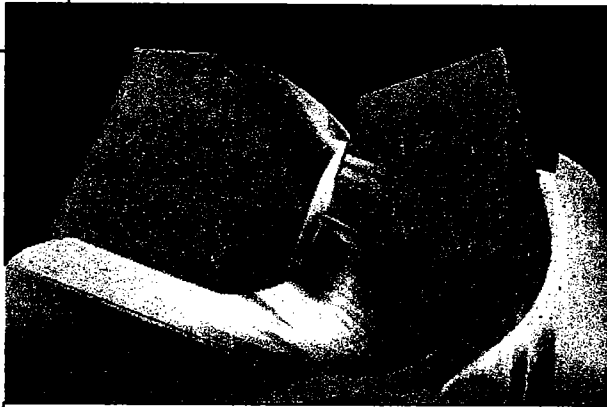
Luminance surveys of the Founder's Room confirm that there is significant light reflection from three surfaces, the "eye" and the two "knees." The eye reflectance is a compound reflectance from two adjacent surfaces and the eye itself, resulting in the equivalent of a taillight or bicycle reflector. The light is very bright and collimated. Furthermore, the surface is well above the level of the trees; thus, there is no filtering effect. The main wing of the Disney Hall immediately to the southwest of the Founder's Room shades the "eye" in much of September and the winter months, but the reflections reappear in the summer months.

*Luminance Plot of "Eye"*

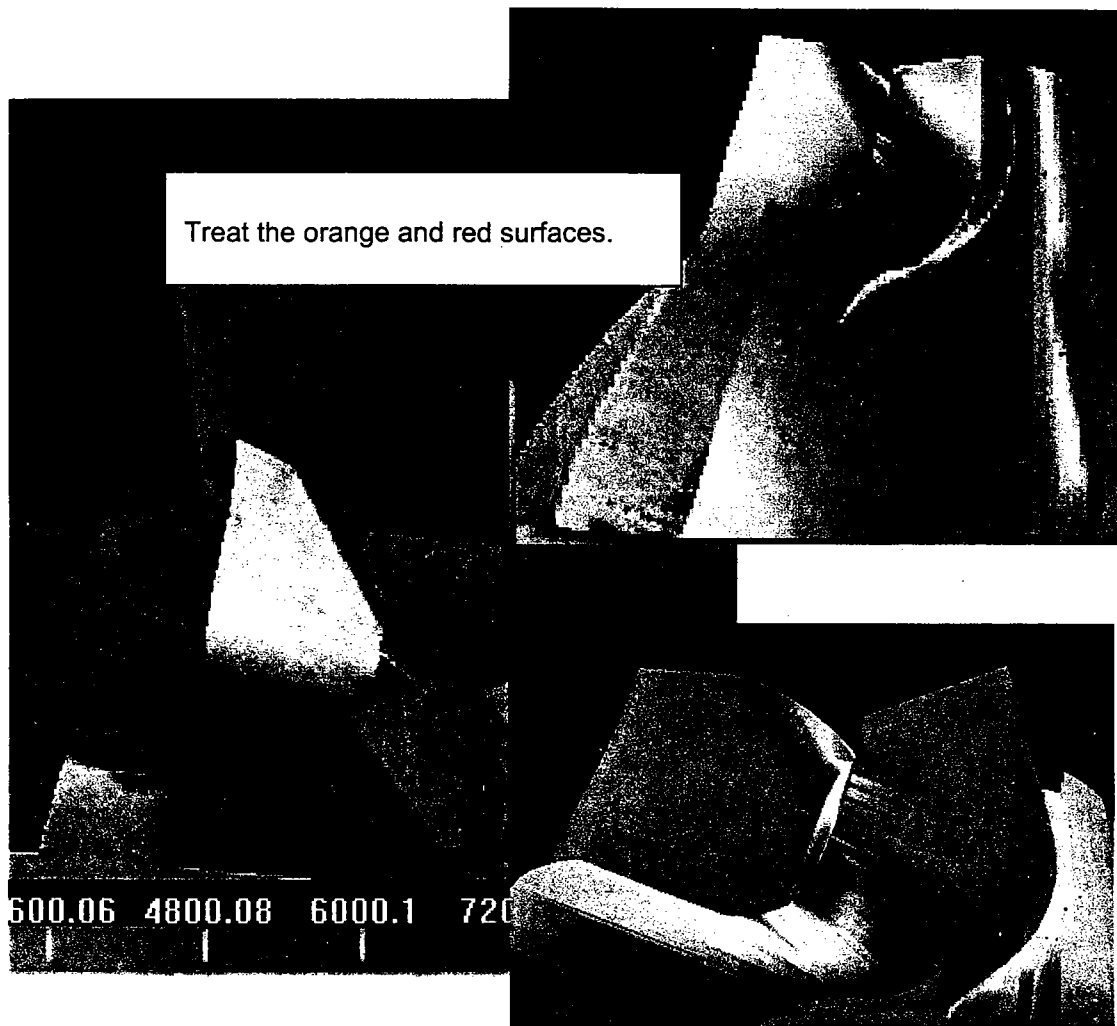
The upper portions of the Founder's Room facing the Promenade Towers will, at various times, send a beam of collimated light into the balconies and apartments. This will cause visual discomfort, which has been simulated, and is likely to cause an increase in heat gain; however, the exact heat gain has not been measured or simulated. The lower surfaces of the "knees" have high reflectance as well. The lower floors of the Promenade Towers are generally shielded or filtered by the trees, although a few units may "see" between the trees. Unfortunately, the uppermost floor will still get some direct reflection, even from the lower panels.

The surfaces indicated in orange or red should be treated.

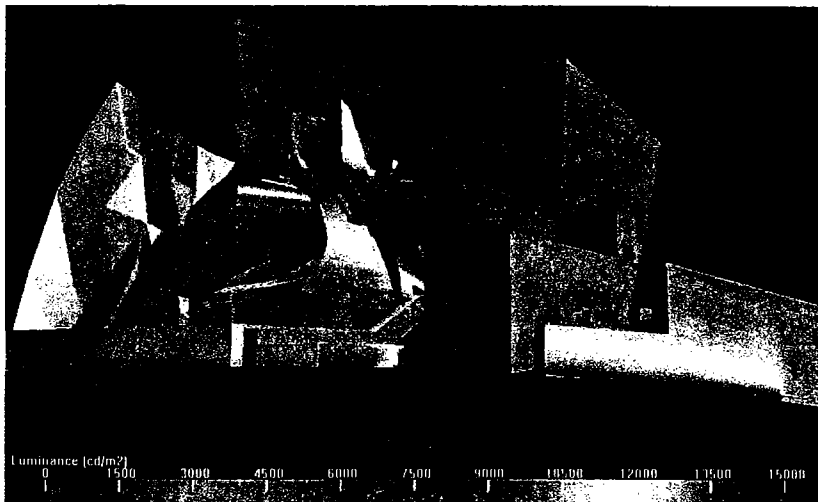
*View from Diagonal Point Across Intersection, or Center of Intersection*

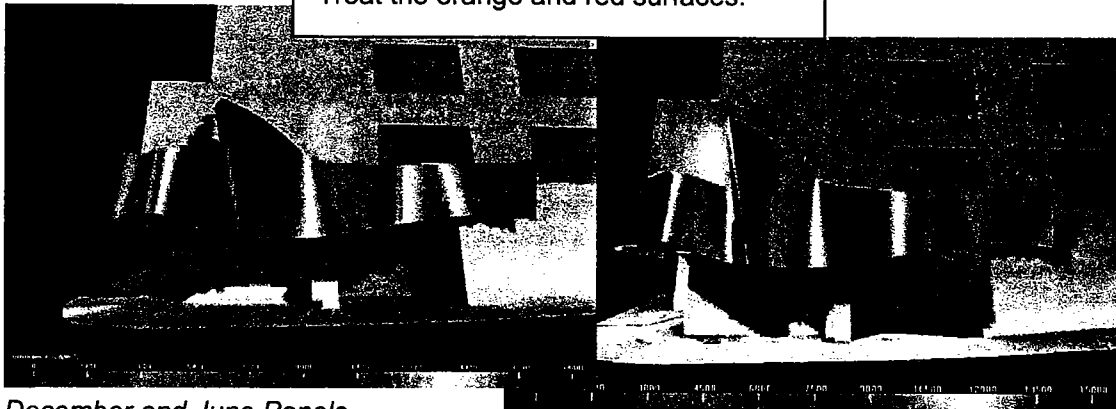
*December and June Panels*

For the first time, the simulations and the photographs seem to indicate slightly different outcomes. The photograph and the simulation of the June 4:00 p.m. glare seem to match exactly. However, the photograph and the simulation of the March 2:00 p.m. glare present somewhat differently. Although the “prow” of the marquee is at a high luminance level, the glare itself is cast downward and parallel to 2<sup>nd</sup> Street in such a tight fashion that the traffic at the intersection does not see it. Where the glare image has diffused to a lower intensity, it is seen by traffic but is not problematic. In June, the “prow” throws light into the intersection.

Treat the orange and red surfaces.

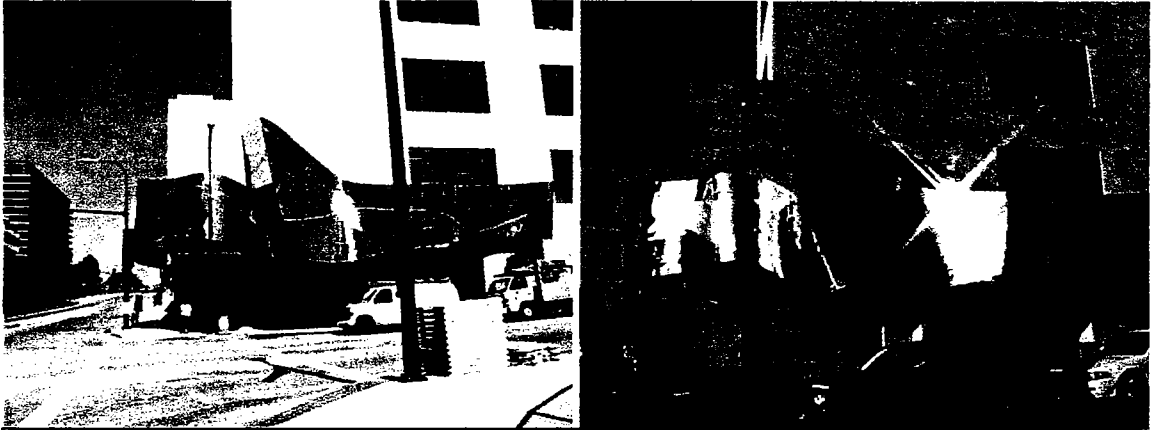
*December and June Photographs*

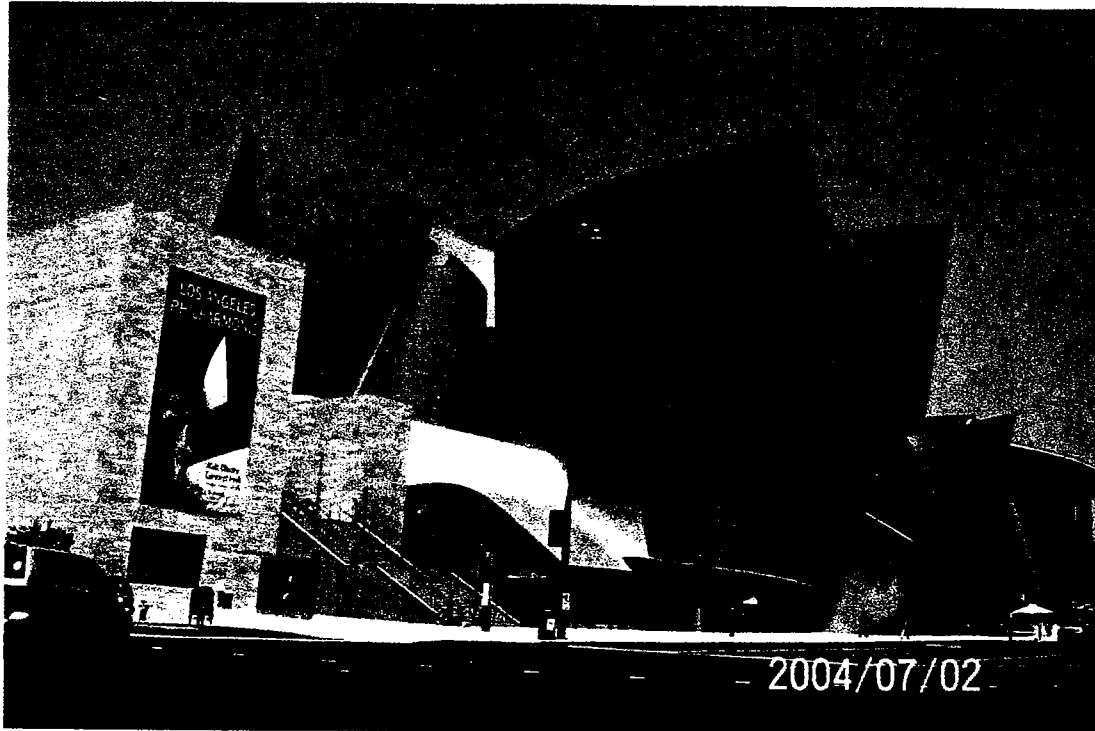
Note that the upper portion of the roof over the Patina Restaurant is glowing so strongly that the photo simply records it as pure white. Fortunately, it does not focus a beam, so there is no glare (normally indicated by lens flare) or direct interference with traffic.

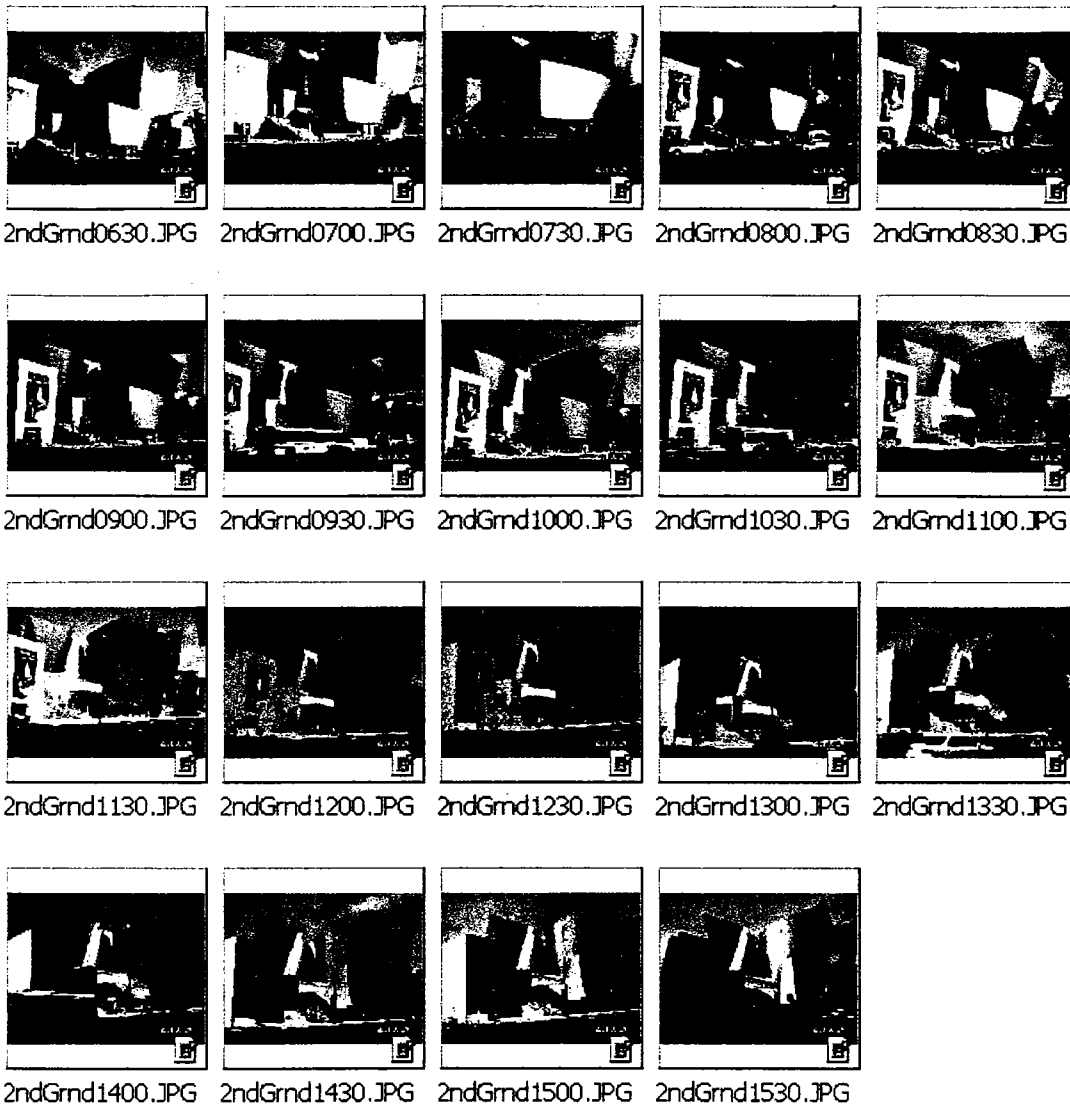
Note that there are some photographs that are not clearly time-stamped and are therefore labeled in a sequential fashion. There is no glare in the photographs, so the time stamp is not critical. (All of the above photographs are courtesy of Sapphos Environmental, Inc.)

*Photographs of the Intersection of 2<sup>nd</sup> and Grand Streets at Half-Hour Intervals for March*

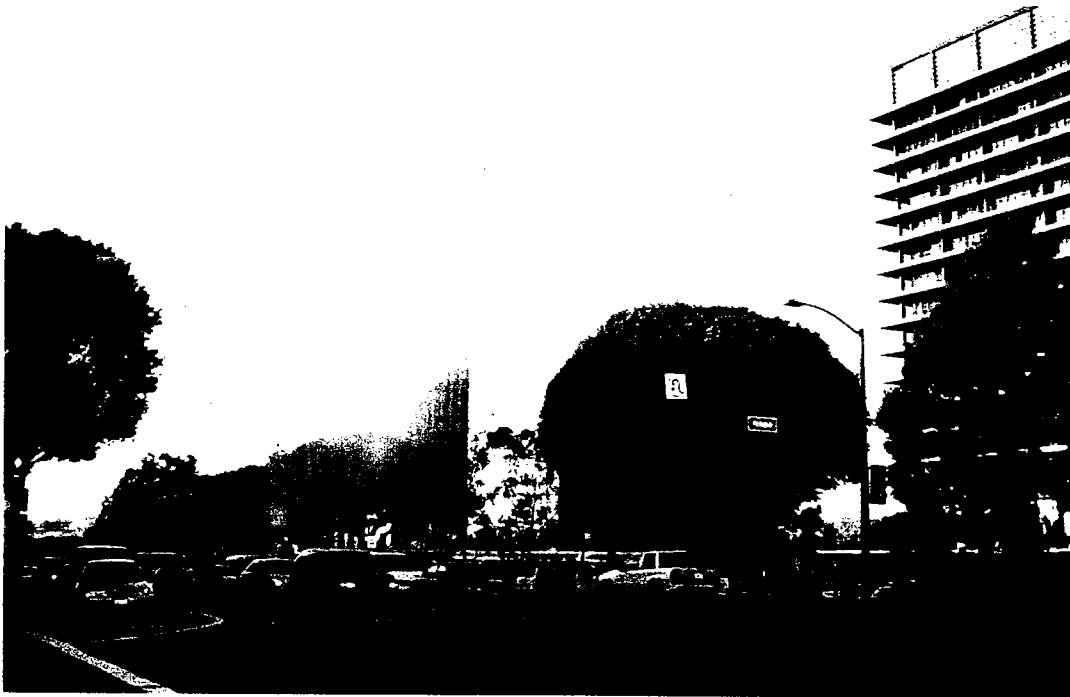
*Glare on Promenade Towers and Intersection of Hope and 1<sup>st</sup> Streets from Older Buildings*

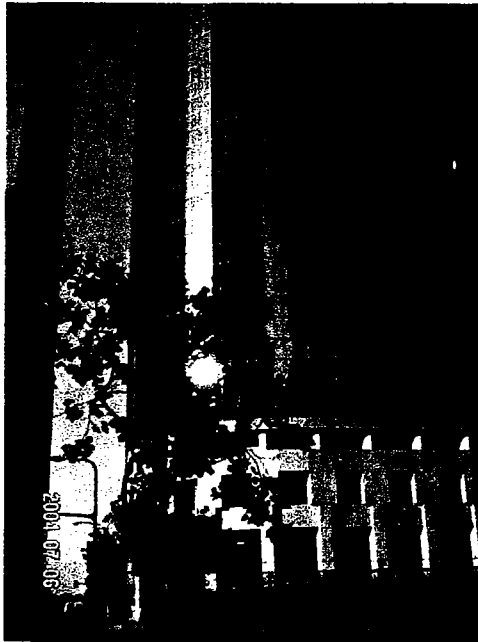
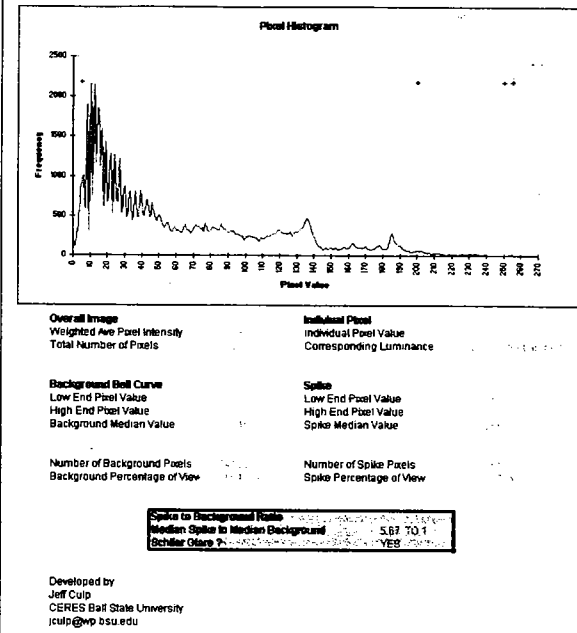
*Deutsche Bank at the California Plaza, yields a glare ratio of 5.67, even with a tree.*

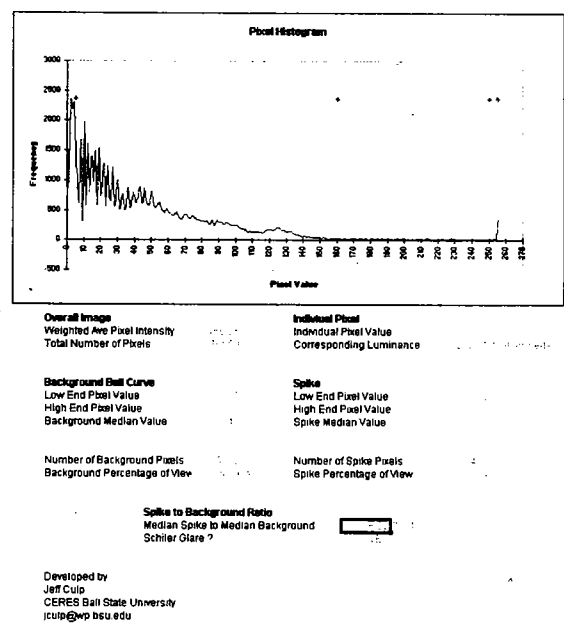
*Charles Schwab at the Wells Fargo Center, 355 South Grand Avenue, yields a glare ratio of 6.62.*

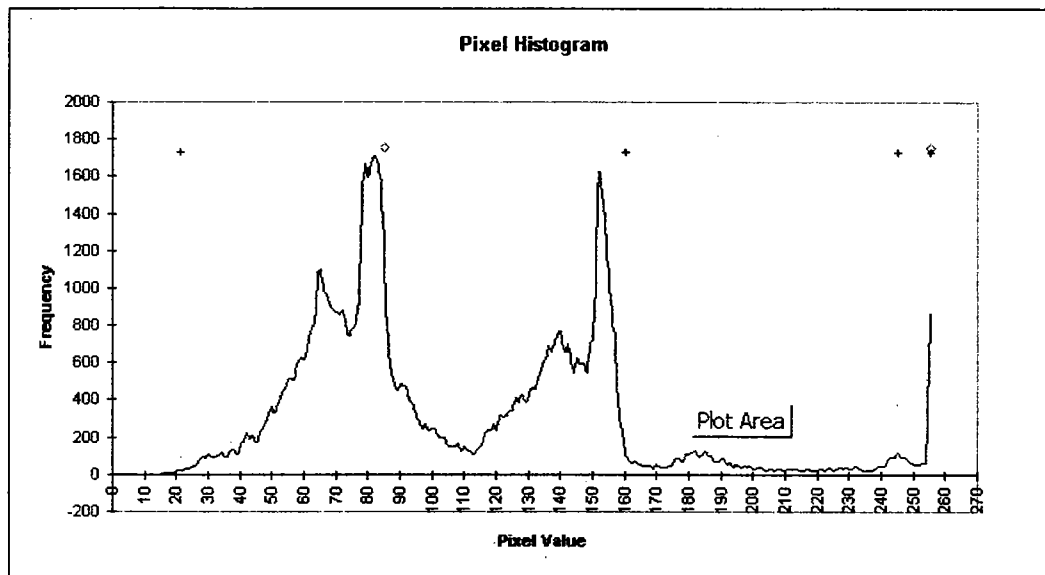
### Histogram of Founder's Room "Knee" Surface

The output page of the program, which includes the histogram and the analysis, is included in its entirety. Note that discomfort glare is clearly indicated.

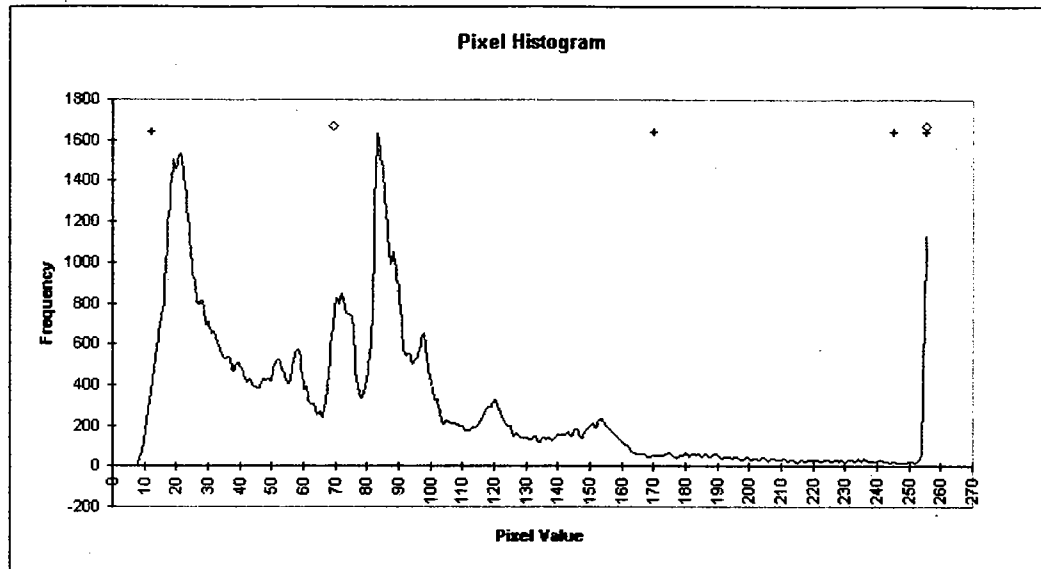
### Histogram of Founder's Room "Eye" Surface

The output page of the program, which includes the histogram and the analysis, is included in its entirety. Note that discomfort glare is clearly indicated.

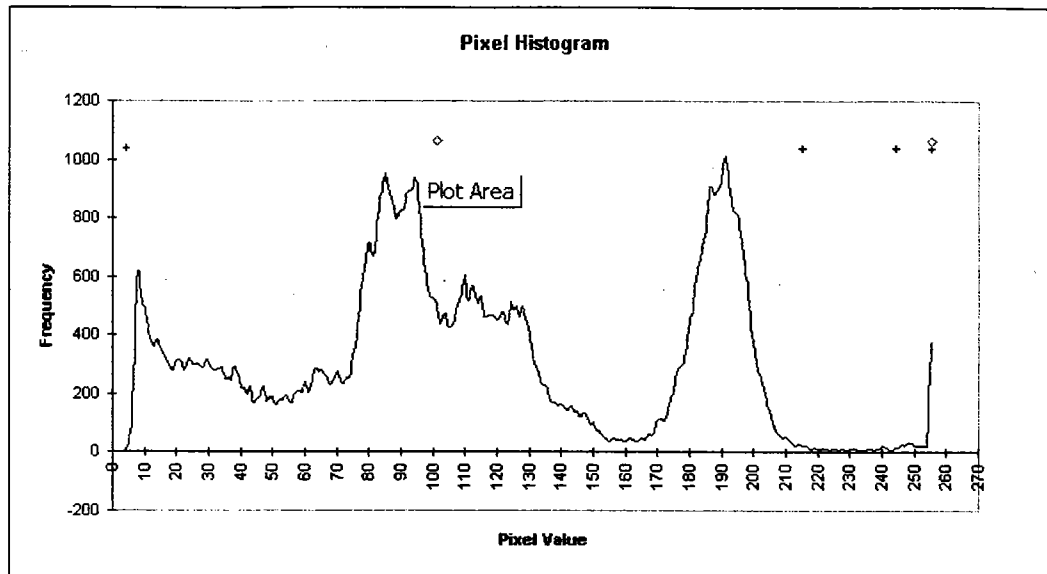
The output page of the program, which includes the histogram and the analysis, is included in its entirety. Note that glare is possible but not definite.

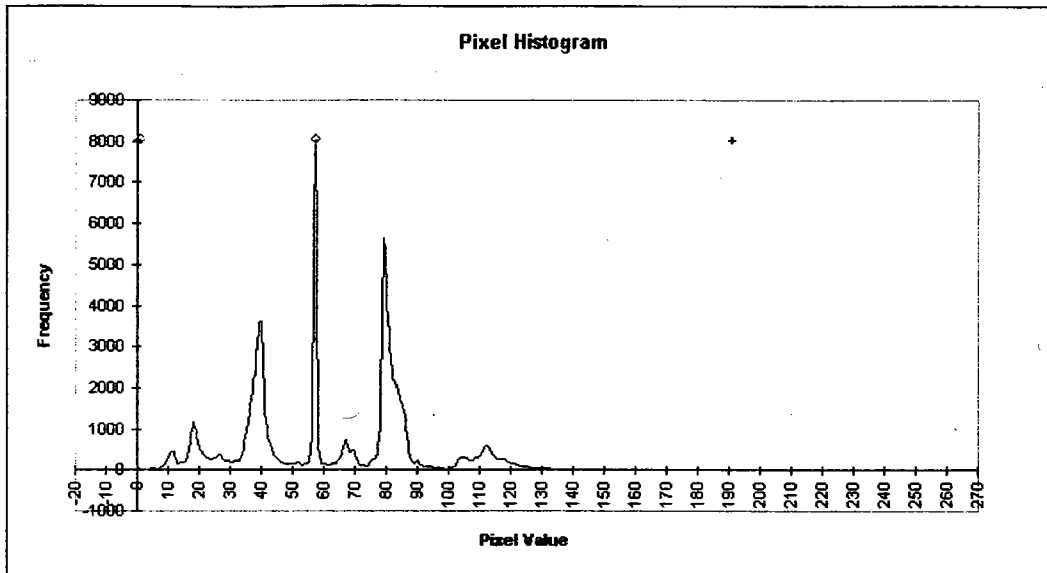
The output page of the program, which includes the histogram and the analysis, is included in its entirety. Note that there is definitely no glare.

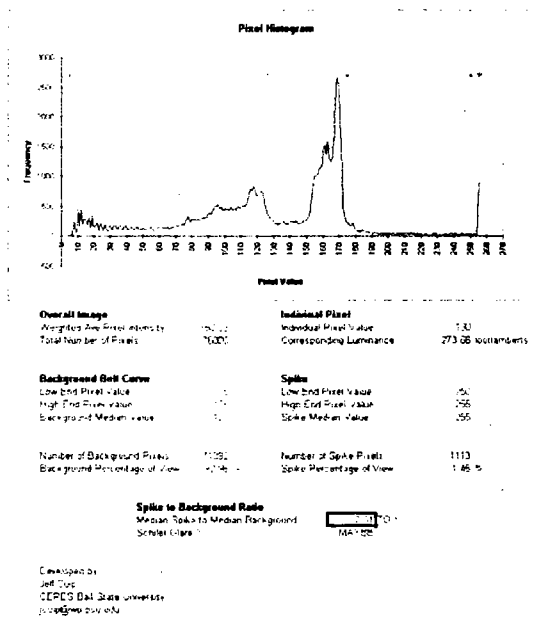
*Histogram of the intersection of 1<sup>st</sup> and Grand Streets at 11:50 a.m. on July 2.*

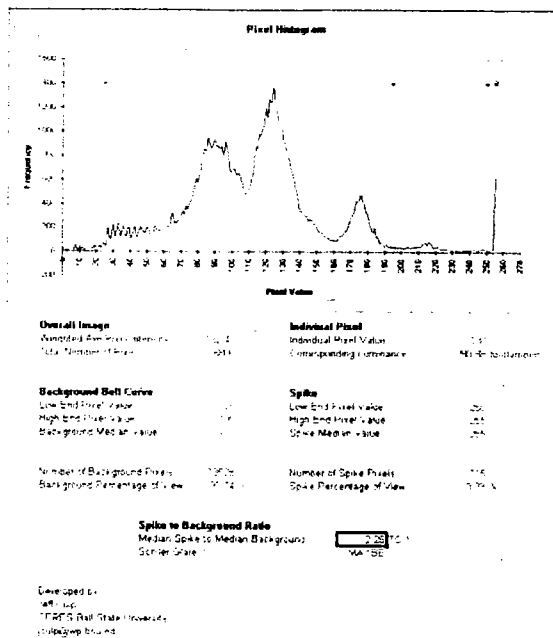
*Histogram of the Intersection of 2<sup>nd</sup> and Grand Streets at 1:20 p.m. on June 23*

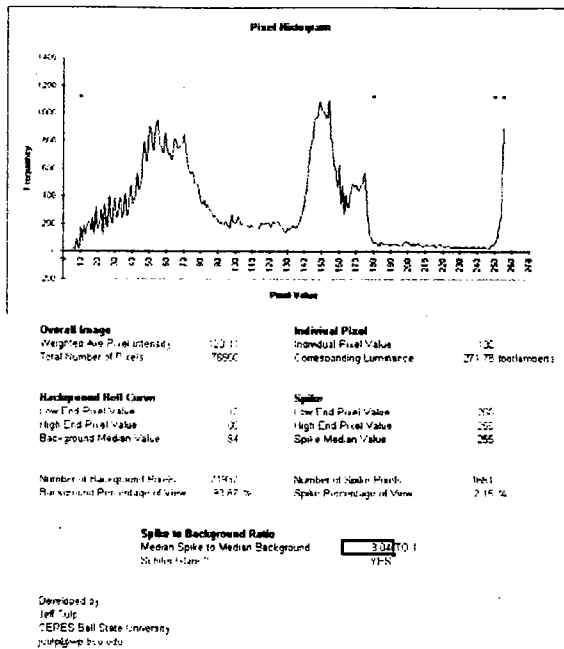
*Histogram of the Intersection of 2<sup>nd</sup> and Hope Streets at 7:15 p.m. on June 23*

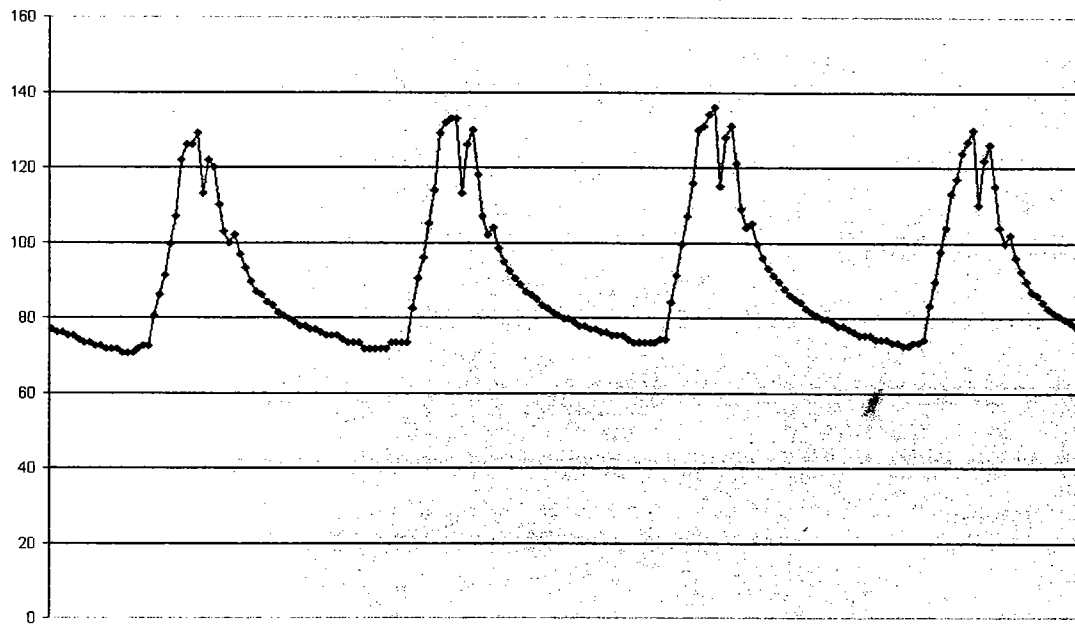
It is interesting to note that on all of the sensors, just before the expected peak temperatures occur, there is a sudden dip. Such a dip would be explained by a massive shadow covering the entire marquee. Inspection of the site confirms that 333 South Grand Street (currently the Wells Fargo Bank building) shades the marquee at that time of day, during winter months. This indicates that summer months (with higher sun angles and higher ambient air temperatures) will achieve higher surface temperatures. It would be useful to repeat the test in July when the marquee is not shaded by the Wells Fargo or the BP (formerly Interstate Bank) Building.
